Manhole Inspection Summary

Manhole # S07EE1023MH

Location Address: **3801 COLD SPRING LANE**

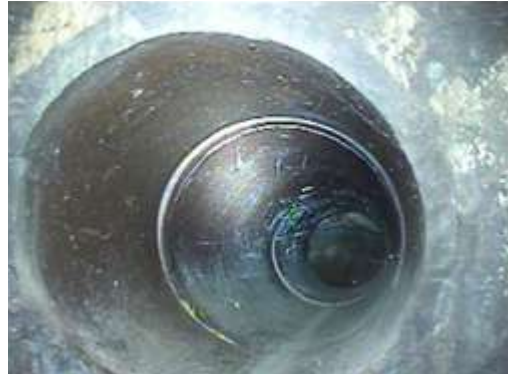
POSSIBLE OVERFLOW @ 12 O' CLOCK
LINE 1 -6.2 FT

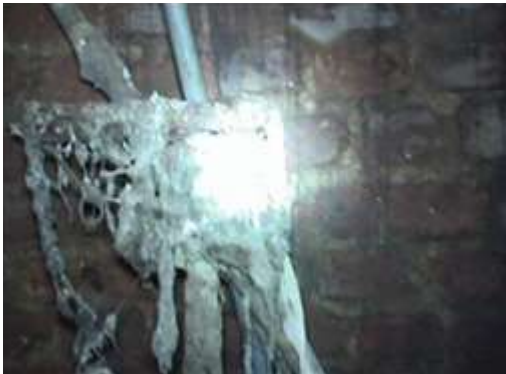
Defect 1

Count: **4** Missing: **0** ☒ **Corroded**

☒ **Evidence Of Surcharge** Depth: **3** (ft.) ☐ Active Surcharge Present

EVIDENCE OF SURCHARGE and
corroded step

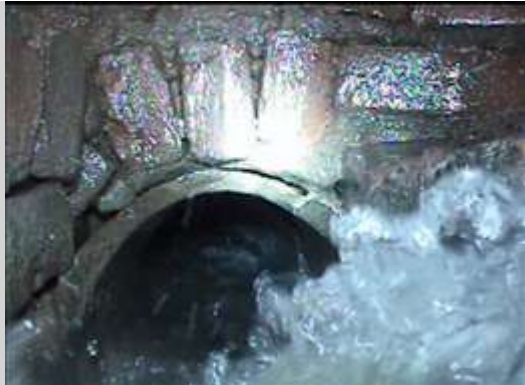
12 O'Clock Outflow

8 in. Circular Gravity Sewer
Pipe Out @ 12 O'Clock

Pipe Height: (in.) Direct
Pipe Material: **Clay** ☐ Pipe Lined
Invert Depth: **10.22** (ft.) Flow Characteristics: **Turbulent**
Deposits: ☒ None ☐ Mud ☐ Sludge ☐ Debris ☐ Grease
Silt Depth: (in.) Deposits Extent:
Infiltration: **None** Pipe Seal Cond: **Cracked**

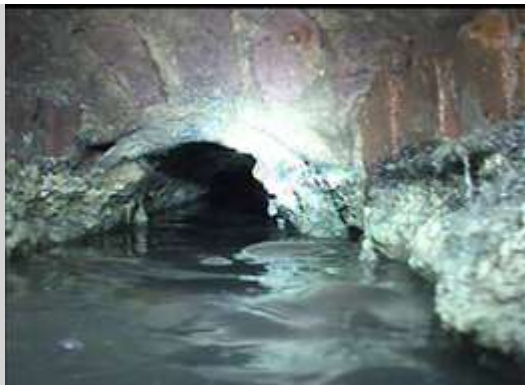
6 O'Clock Inflow

8 in. Circular Gravity Sewer
Pipe In @ 6 O'Clock

Pipe Height: (in.) Direct
Pipe Material: **Clay** ☐ Pipe Lined
Invert Depth: **10.00** (ft.) Flow Characteristics: **Slow**
Deposits: ☐ None ☐ Mud ☐ Sludge ☐ Debris ☒ Grease
Silt Depth: **1.5** (in.) Deposits Extent: **Medium**
Infiltration: **None** Pipe Seal Cond: **Cracked**

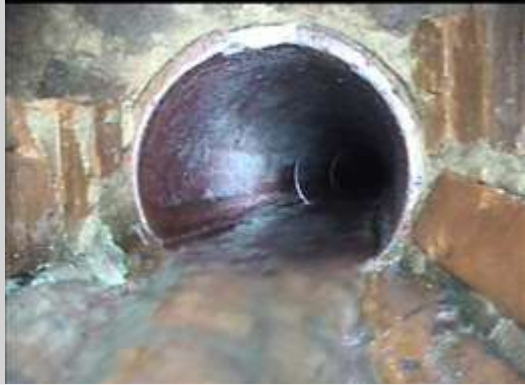
9 O'Clock Inflow

8 in. Circular Gravity Sewer
Pipe In @ 9 O'Clock

Infiltration: **None** Pipe Seal Cond: **Sound**
